# Rehabilitation of structurally damaged and corrosion-affected structures using polymer systems

**M. K. Kamat, B.V. Bhedasgaonkar**

*The authors report three case studies of structurally-damaged concrete structures where the extent of corrosion of reinforcement was also high. In all the three cases, polymer-based materials were used for rehabilitation.*

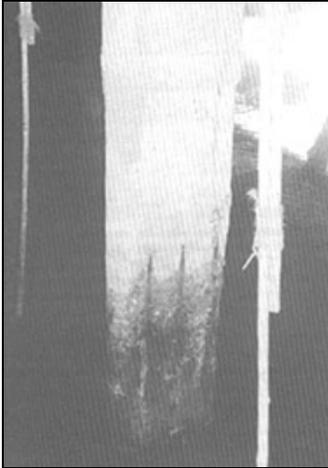
A major damage to the structure occurred in the main columns forming the portals of the pump house structure. Beams and columns at the water intake side of the pump sump were also badly corroded. Reinforcement in columns and beams showed signs of heavy corrosion. It showed heavy scaling too. The portion of column between high and low tide was most damaged. The size of the column was reduced from 300mm x 600mm to 230mm x 450mm, indicating an alarming situation from structural point of view also. Bottom reinforcement of the beams gave away completely when loose concrete from bottom was chipped off.

The alternate wetting and drying in sea water, attack of chlorides, attack of effluents which were accumulating in the pond along with general marine environment were the main contributing factors responsible for corrosion. There was no concrete protective system adopted at the time of construction.

Fig 1 shows the condition of the columns.

**Fig1 : Existing corroded condition of the RC column**

Decision was taken to rehabilitate the damaged portion of the structure with polymer modified mortar in preference to conventional jacketing of the elements with concrete. This was on account of considerably better bond, increased flexural and tensile strengths and resistance to chemical attack exhibited by polymer mortars.

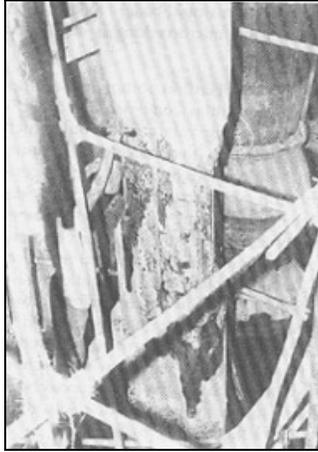
**Fig3 : Low viscosity monomer impregnation in the core of the RC column**

Prior to repairs, the client got critical portion of the structure tested from Messrs Composites Combines, Bombay. Ultrasonic pulse velocity testing was carried out which indicated a velocity of 3,200 m/s. It was decided to improve the core of columns in these locations by injecting low viscosity monomer Monopol. Core was also impregnated with Monopol by repeated brush application, Fig 3.

This monomer forms a polymer matrix within the concrete matrix and improves the core strength. Moreover, the corroded reinforcement was derusted and protected with IPN anticorrosive coating. Additional reinforcement in the form of main bars was provided. Expanded wire mesh troughs were used to encase bottom reinforcement of beams where shear as well as main reinforcement had given away. Repairs with Monobond polymer latex were carried out on surfaces having

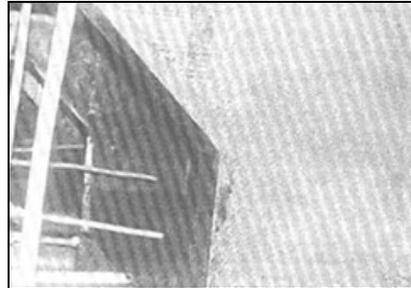
**Fig 4 : View of restored RC column after protective coating treatment**

epoxy bond coat. Finally, the entire surface of the structure was given anticorrosive protective coating with Corroseal, Fig 4.

UPV tests were conducted on repaired portion at the same location where the earlier tests were conducted. The velocity improved to 3,700 m/s justifying the method of repairs adopted.

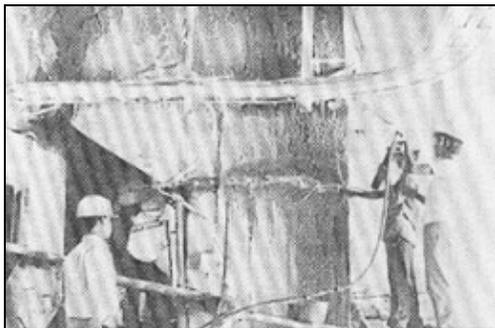
A leading cement manufacturing plant in Karnataka had problems of severe vibrations in its lime stone crusher foundation. The foundation has four main columns supporting the deck on which the crusher is located. One column developed crack at the column top / deck junction. This also happened to be the location of the construction joint. The crack width increased gradually when the machine continued to be operated even after crack development. This resulted in severe vibrations of the crusher. The cross section of the column top is about 2m x 1.35m. Since the crusher was operated even after the development of the crack, it was felt that there could be a likelihood of the disbonding of the vertical reinforcement from adjacent concrete as well as propagation of the crack, lateral to the direction of the bar due to vibrations. Very low viscosity monomer was selected for impregnation of the core of the column by injecting it into the crack under pressure until no more low viscosity monomer could go in. The amount of low viscosity monomer injected was considerably higher than the crack volume, indicating that the core was impregnated and the possible cracks around the vertical bars were sealed. Finally after 24 hours of low viscosity monomer injection, injectable epoxy resin was injected into the crack to ensure its complete sealing, Fig 5.

**Fig5 : Grouting with low viscosity monomer for foundation of lime stone crusher**

The vibration of the foundation was reduced from over 300 microns to within the acceptable limit. The entire work was done in three days and crusher was brought back into operation immediately, resulting in minimum shutdown.
