Sulphate Resistance of Concrete and Effect of Sulphate Attack

Niragi K. Dave

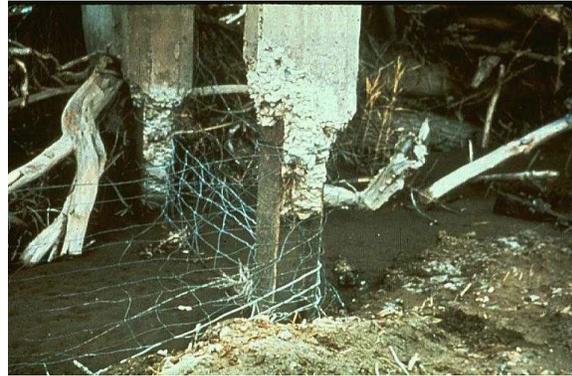
Fig. 1 Bridge Column in Sulphate Soils Due to External Sulphate attack.

This is the more common type and typically occurs where water containing dissolved sulfate penetrates the concrete. A fairly well-defined reaction front can often be seen in polished sections; ahead of the front the concrete is normal, or near normal. Behind the reaction front, the composition and microstructure of the concrete will have changed. These changes may vary in type or severity but commonly include:

Extensive cracking, Expansion, Loss of bond between the cement paste and aggregate and alteration of paste composition, with monosulfate phase converting to ettringite and, in later stages, gypsum formation. The necessary additional calcium is provided by the calcium hydroxide and calcium silicate hydrate in the cement paste

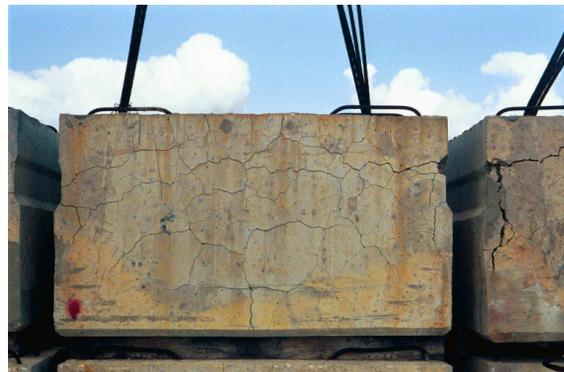
Fig.2 Concrete Box Beam due to sulphate attack

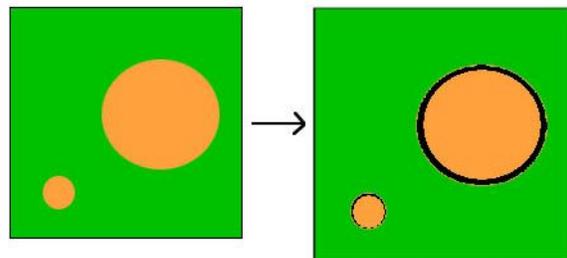
Fig.3. Diagram showing how paste expansion produces a small gap around small aggregate particles and a bigger gap around larger particles.

DEF causes a characteristic form of damage to the concrete. While the paste expands, the aggregate does not. Cracks form around these non-expanding 'islands' within the paste - the bigger the aggregate, the bigger the gap. DEF usually occurs in concrete which has either been steam cured, or which reached a high temperature during curing as a result of the exothermic reaction of cement hydration. As the curing temperature of concrete increases, ettringite normally persists up to about 70 C. Above this temperature it decomposes. In mature concrete, monosulfate is usually the main sulfate-containing hydrate phase and this persists up to about 100 C. DEF could occur in concrete which was heated externally, e.g.: from fire. An ettringite molecule contains 32 molecules of water; ettringite formation therefore requires wet conditions.

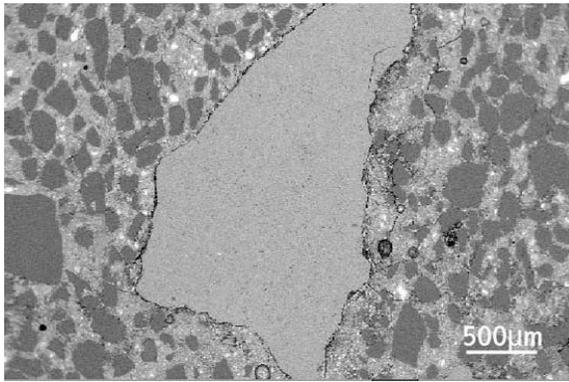
Fig.4. Scanning electron microscope image of limestone aggregate particle. The cement paste has expanded and a gap has formed between the aggregate and the cement paste. This is characteristic of damage to concrete due to DEF. The aggregate is no longer contributing to concrete strength, since it is effectively detached from the cement paste. Often, these gaps become filled with ettringite.

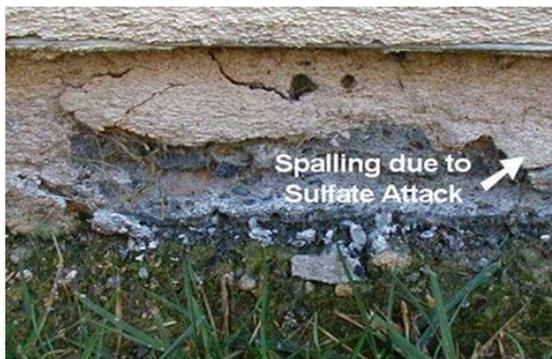
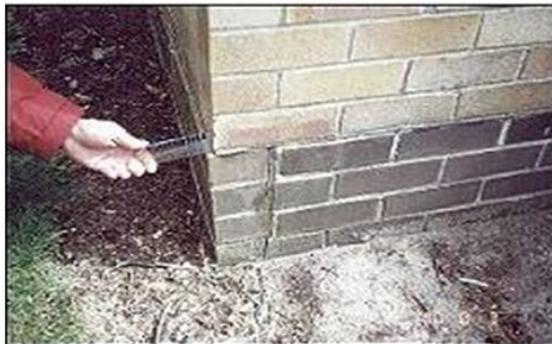
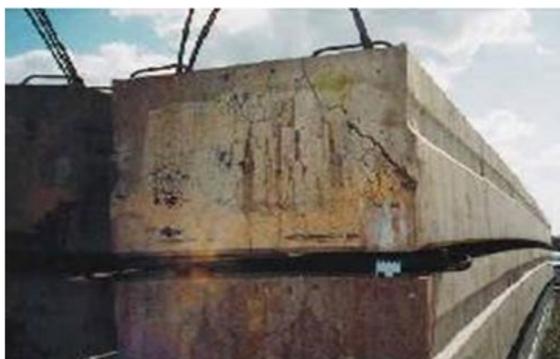
Fig.5. Spalling due to Sulphate attack
