# Rehabilitation of structurally damaged and corrosion-affected structures using polymer systems

**M. K. Kamat, B.V. Bhedasgaonkar**

*The authors report three case studies of structurally-damaged concrete structures where the extent of corrosion of reinforcement was also high. In all the three cases, polymer-based materials were used for rehabilitation.*

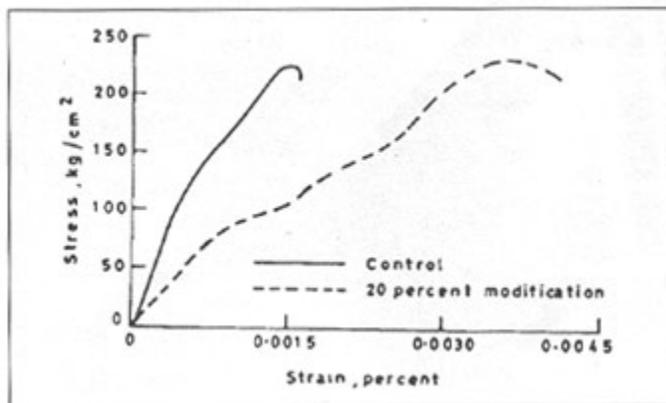
**Fig 2 Stress strain behaviour of Monobond latex modified mortar**

Experimental studies carried out on polymer modified systems have proved the effectiveness of polymer addition. Added to their higher mechanical strength values, their cost-effectiveness renders the repair process economical. Most redeeming feature of these systems is the significant increase in toughness values over cement-based systems, Fig 1. This property alone renders the system most useful for repairs since the repaired areas would not deteriorate under dynamic loadings and energy absorption would be far more uniform throughout the section. Thus, microcracking is eliminated leading to higher durability.
